# TRAIN COLLISION AT GREAT HECK NEAR SELBY, 28 FEBRUARY 2001

## HSE interim report

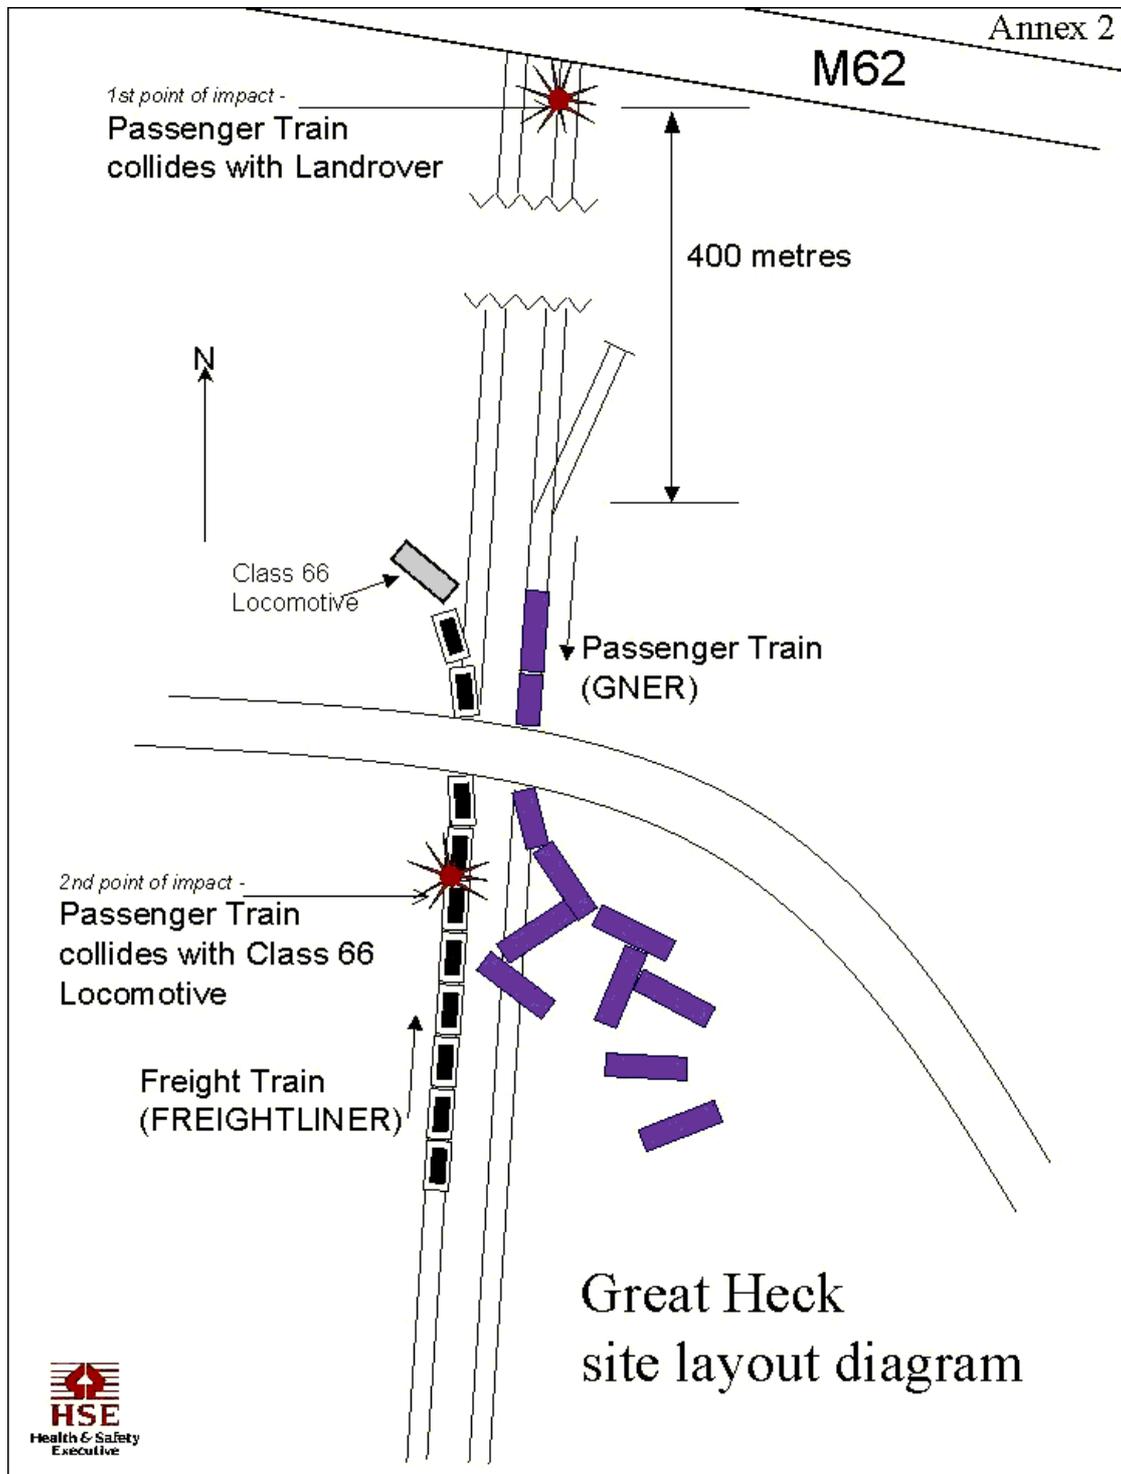
# Annex 2

The line at the location of the collision is straight, without significant gradients, and has a maximum line speed of 125 mph for passenger trains. No speed restrictions were in place at the time of the collision. The lines are electrified by a 25KV overhead lines system and there are signals in the vicinity of the crash site though these would have played no part in the collision sequence. Whilst the coal train had in fact departed early, this early departure was permitted under the operating rules. A schematic diagram of the collision site is attached at Annex 2 as are photographs taken of the site.

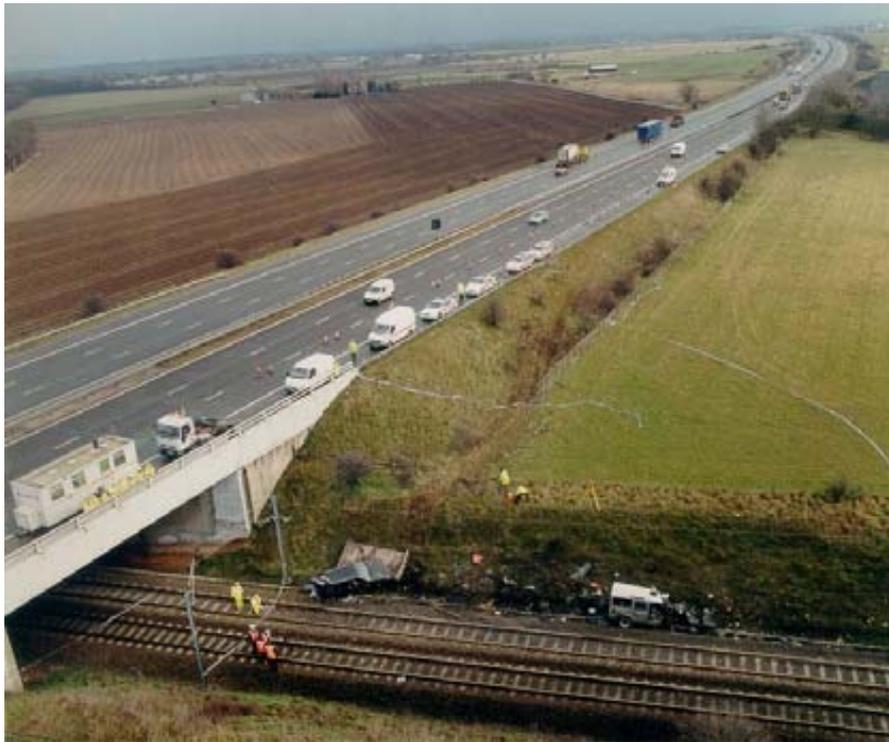
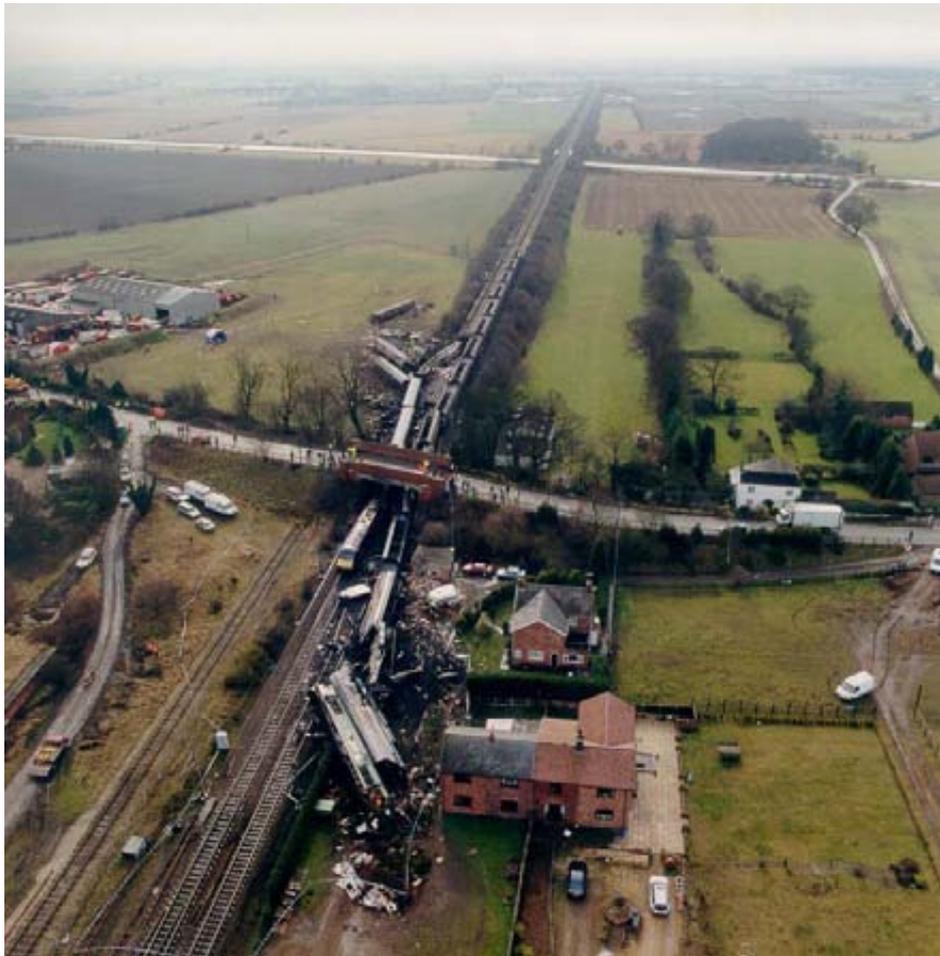
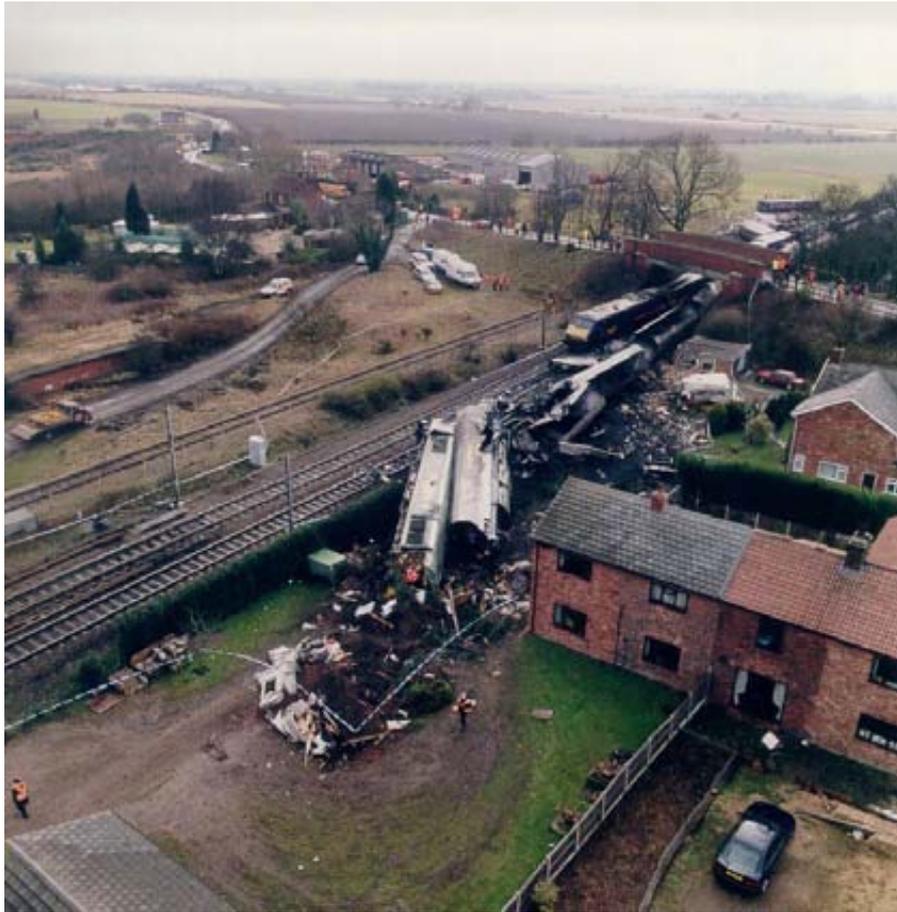
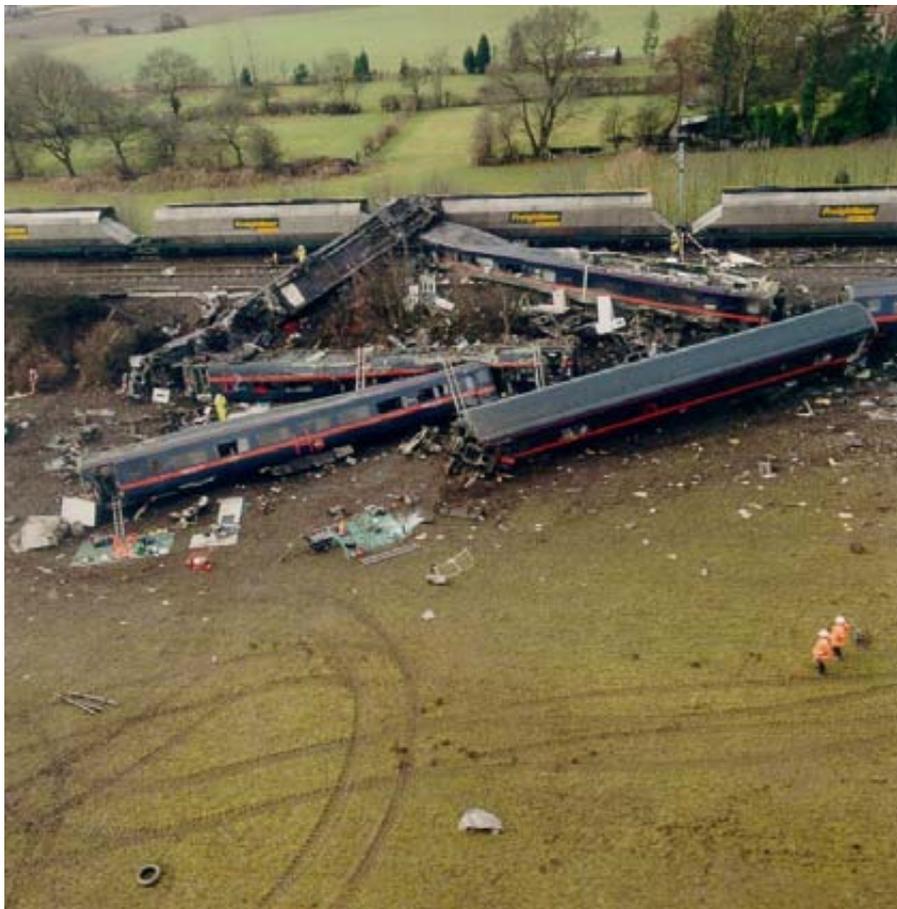
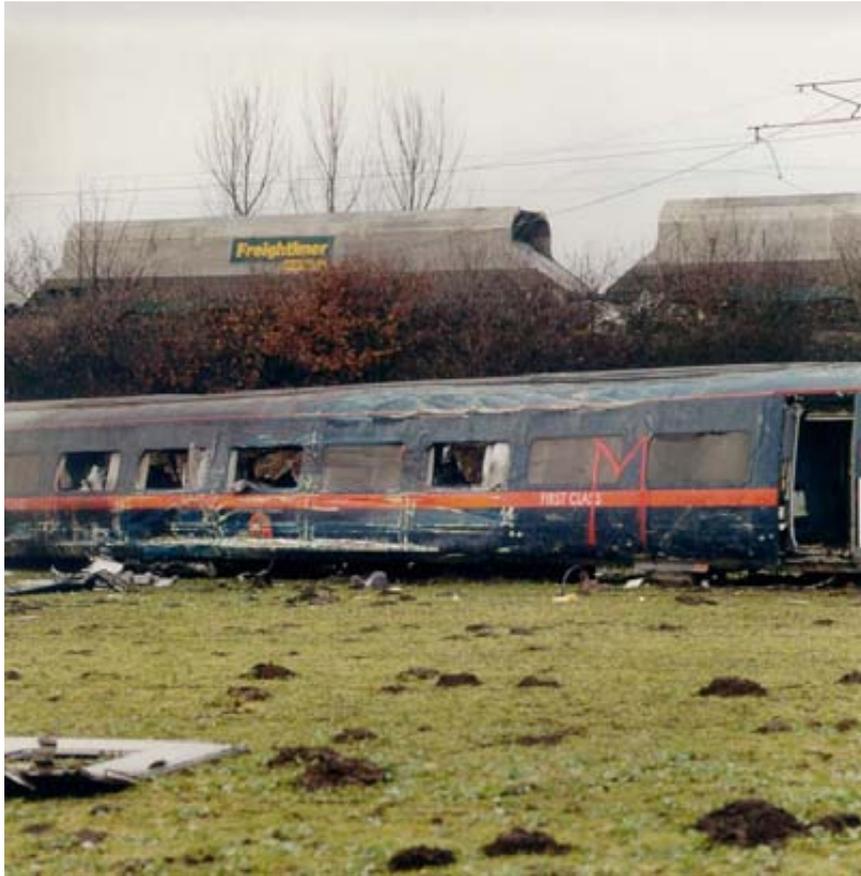
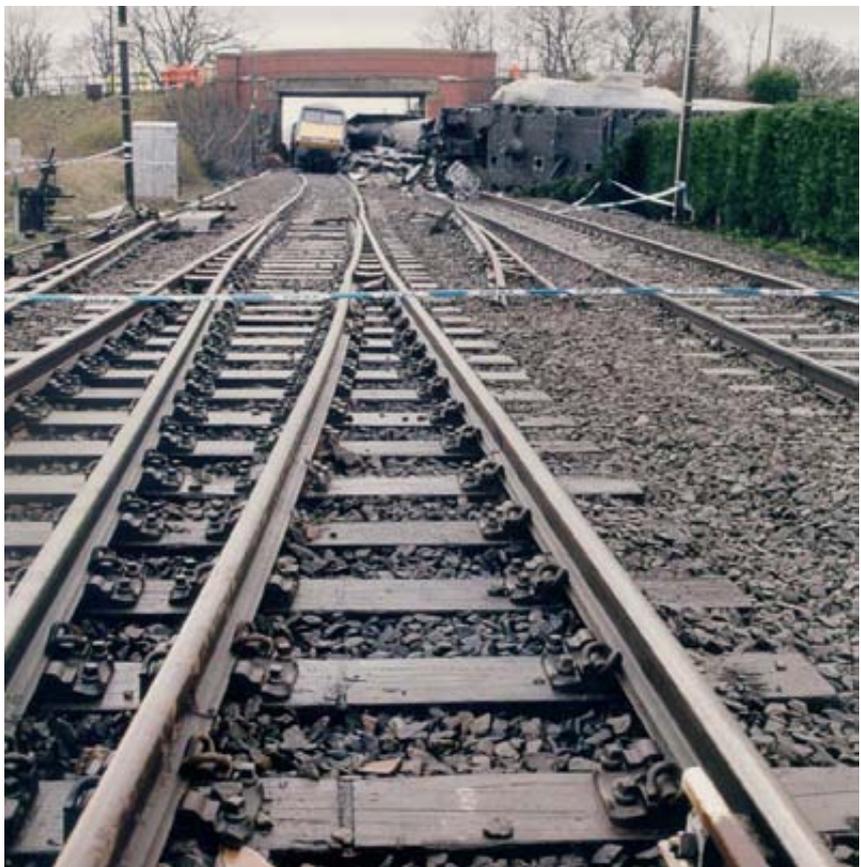
## Photos

The GNER carriages are damaged to varying degrees. Some suffered extensive damage including extreme penetration of the passenger compartments. Examination of vehicles, particularly the DVT vehicle leading the passenger train, will continue on site to the extent necessary and,
